Dubh Loch – Case Study

Dubh Loch

Dubh Loch – Amber (Condition) Survey

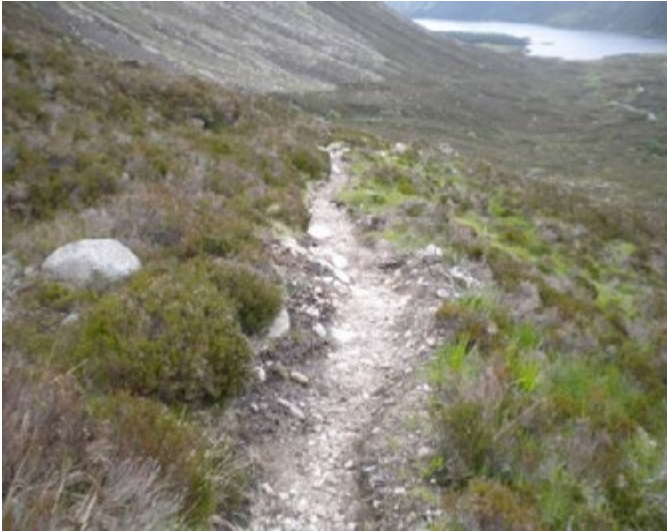
▶ Section 2 – full build

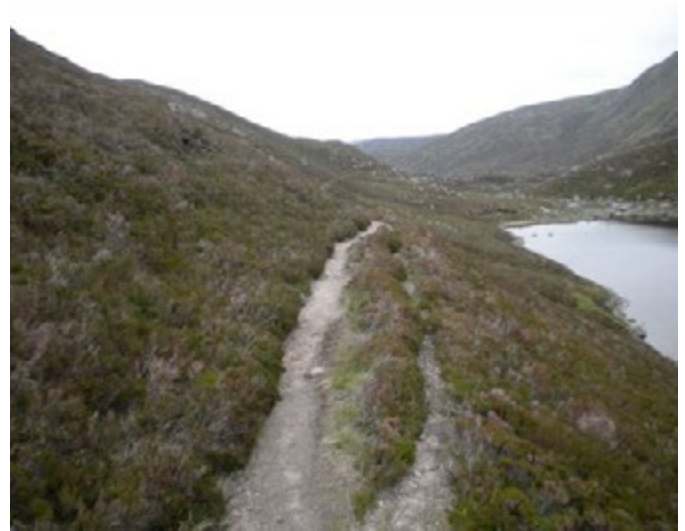
▶ Section 3 – light touch works

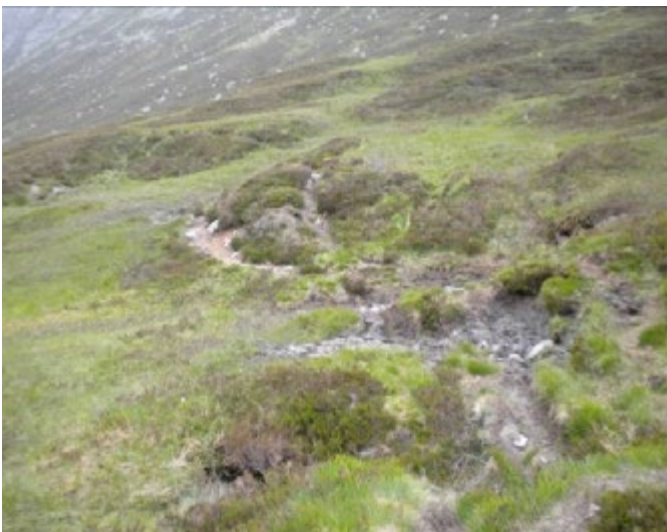
▶ Section 4 – full build

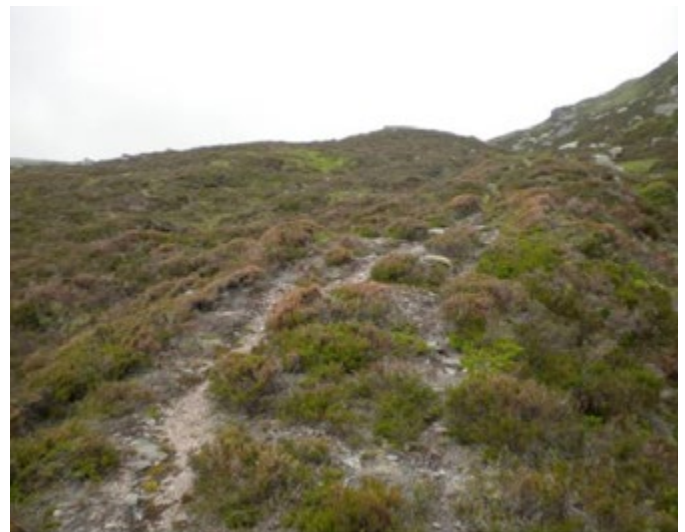
▶ Section – 5 full build

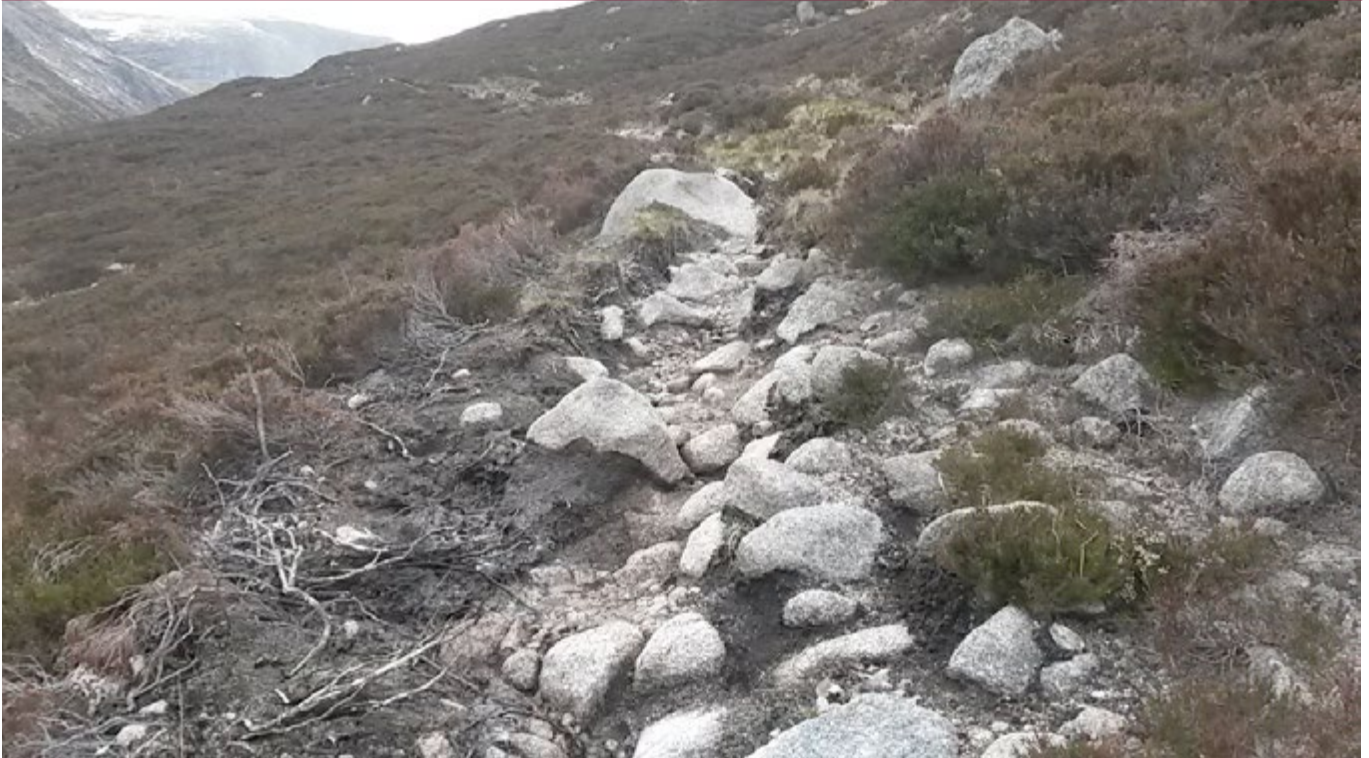
Before works

Weather conditions: Overcast, showery	Date: 27th June 2013
Path Name: Dubh Loch	Surveyor: Donald Mackenzie
Start Grid Reference: NO2732282284	End Grid Reference: NO2289183398
<p>General description of the Path: Path deteriorating and in need of full build with side ditch, water bars and surfacing. Absence of block stone for most of section.</p>

Section:	4
Length:	653m
Grid Ref:	NO2422682675
Surface Type:	Aggregate
Features:	Burn
Paths/Braids:	1/2
Bare Width:	2.4m
Tramp Width:	7m
Gully Depth:	0.1m
LG/XF:	5/17

Roughness:	4
Drainage:	2
Erosion:	2
Dynamism:	2
Condition:	2
Urgency:	2

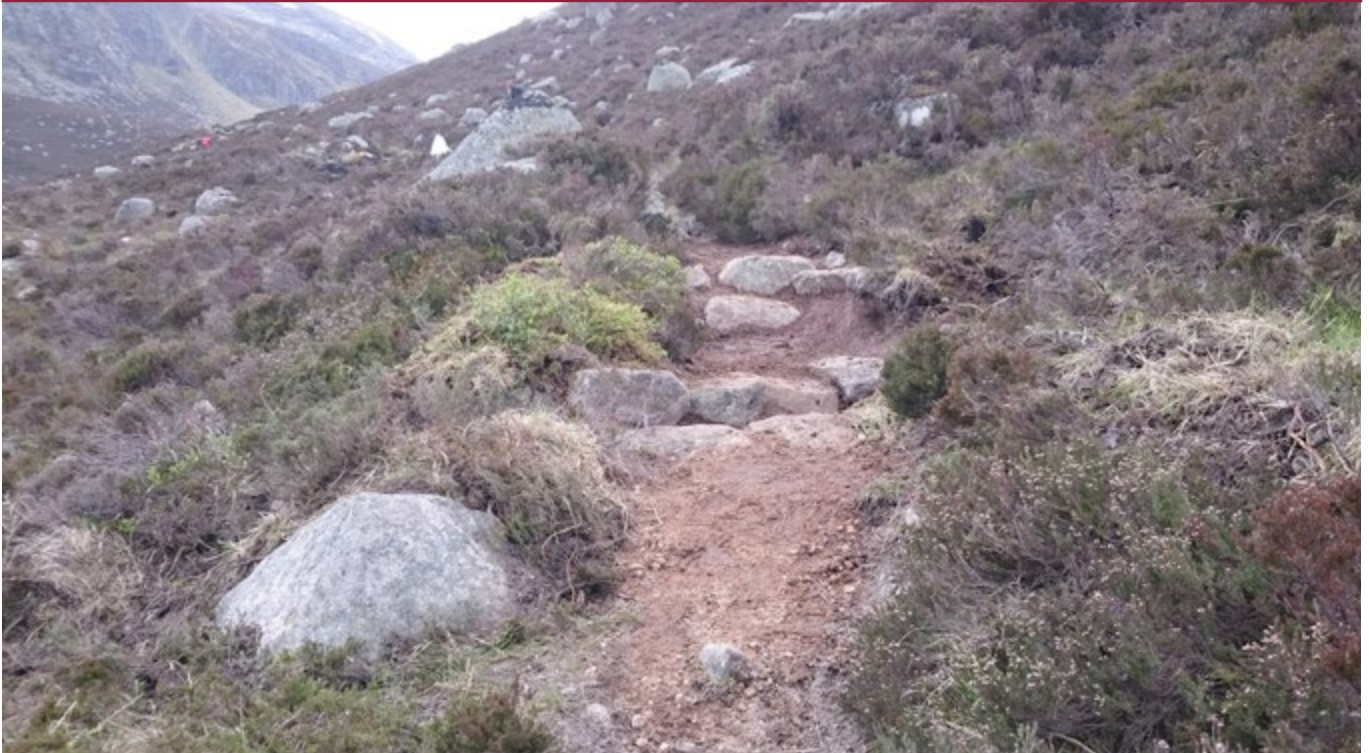
After works

Weather conditions: Sunny and dry	Date: 12th May 2016
Path Name: Dubh Loch	Surveyor: Rosie Winch
Start Grid Reference: NO2732282284	End Grid Reference: NO2289183398
<p>General description of the Path: New aggregate path with good even surface and side ditch. Section in very good condition</p>

Specification	
Section:	4
Length:	653m
Grid Ref:	NO2422682675
Surface Type:	Aggregate
Features:	Burn
Paths/Braids:	1/0
Bare Width:	1.2m
Tramp Width:	1.2m
Gully Depth:	0m
LG/XF:	5/17

Condition	
Roughness:	5
Drainage:	5
Erosion:	5
Dynamism:	5
Condition:	5
Urgency:	5
