Ben A'an – Case Study

Ben A'an

Ben A'an – Amber (Condition) Survey

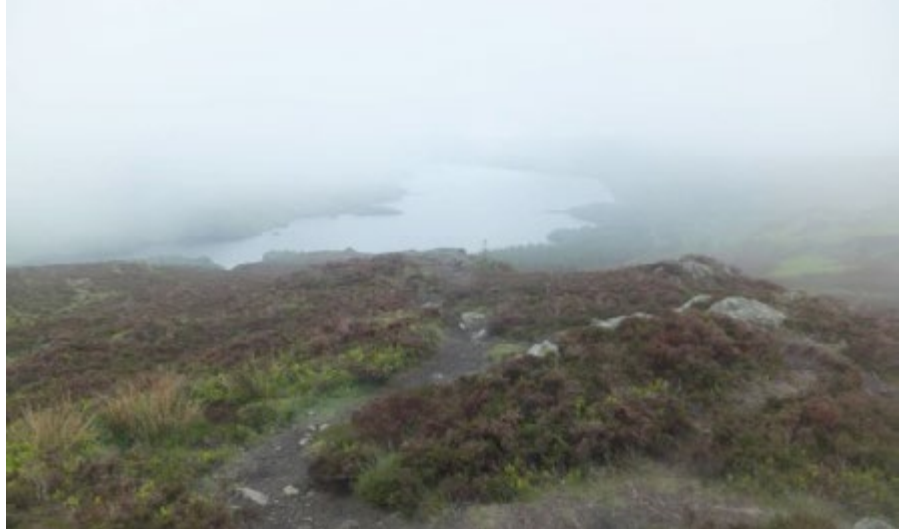
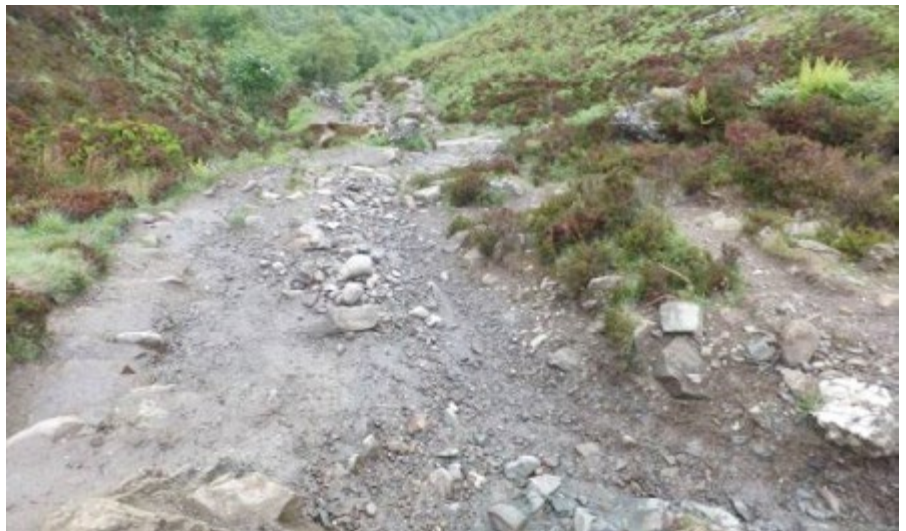
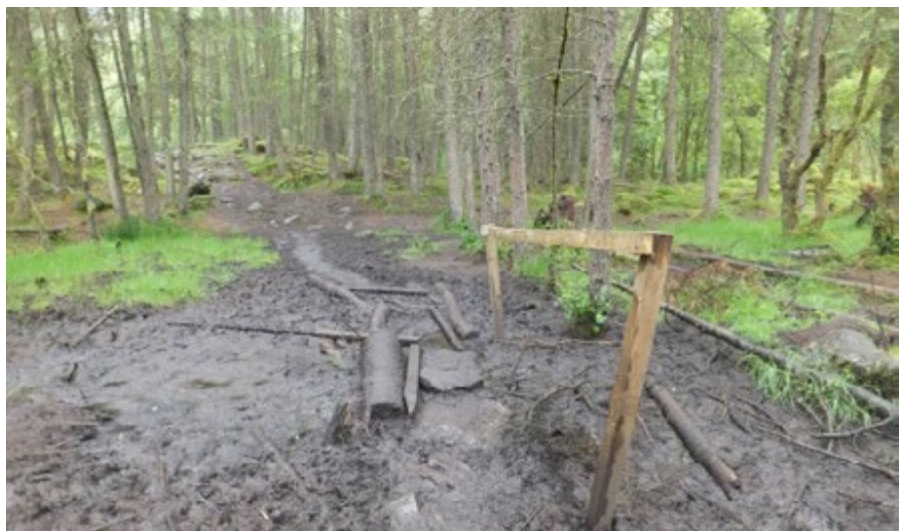
- ▶ Between the upper and lower sections there is a very wide damage zone which has never been built and desperately needs repaired. Current tree cover and steepness of slope means that work here will have to be handbuilt only, and materials will be a challenge!
- ▶ Large sections of the Pathcraft work has failed, and there is almost nothing of the MSC work left.

- ▶ These images show the various conditions and extent of damage to the different sections of the path

- ▶ Full build path all the way to the bridge and beyond.
- ▶ Rebuild sections on the upper slope

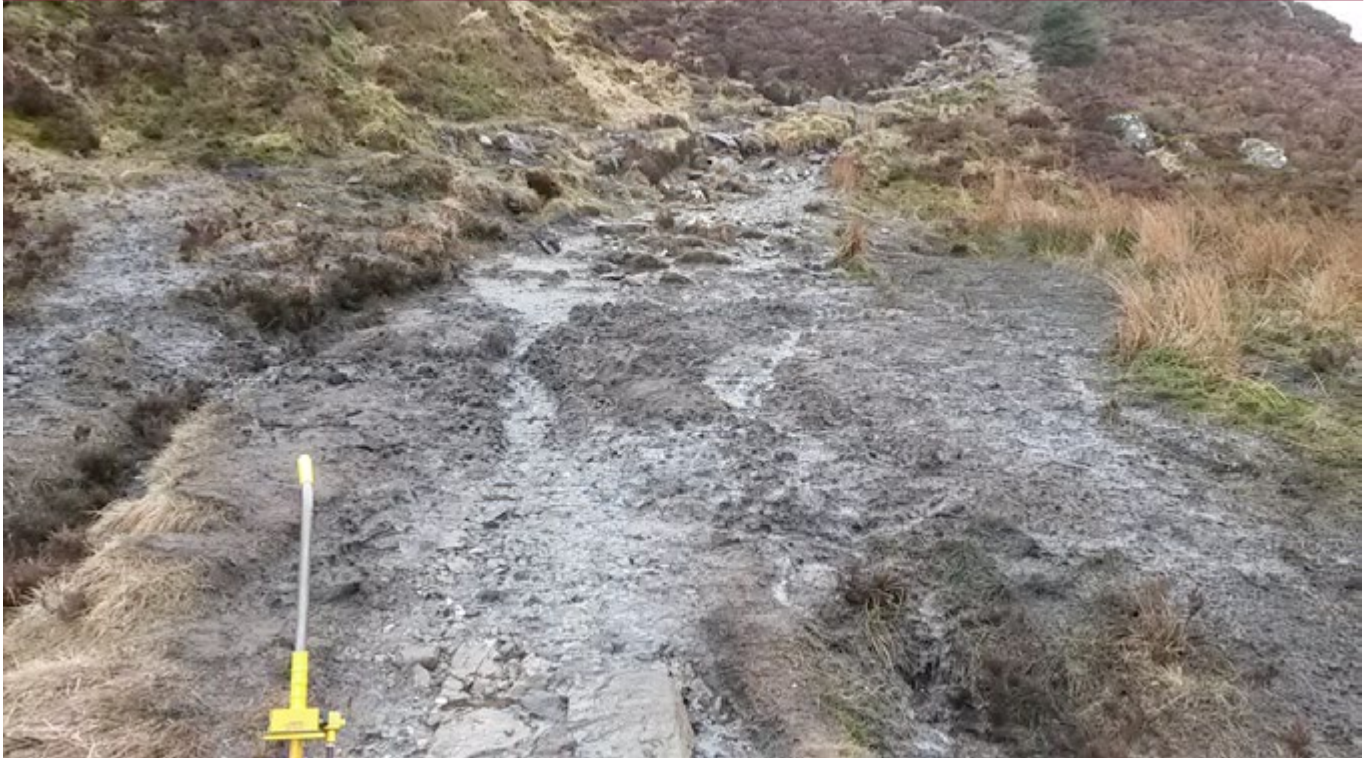
Before works

Weather conditions: Misty, light rain	Date: 2nd July 2013
Path Name: Ben A'an	Surveyor: Dougie Baird
Start Grid Reference: NN 5095307041	End Grid Reference: NN 50733 08339
<p>General description of the Path: Mostly failed stone pitching and some aggregate path. Very boggy in places. Previously built (1990s?) but has failed. Requires 70% rebuild. Pitching and aggregate with substantial revetment work.</p>

Section:	5
Length:	373m
Grid Ref:	NN 5047107972
Surface Type:	Aggregate/stone pitching
Features:	Boulders
Paths/Braids:	3/4
Bare Width:	5.0m
Tramp Width:	12m
Gully Depth:	/0.7m/
LG/XF:	18/21

Roughness:	1
Drainage:	1
Erosion:	1
Dynamism:	1
Condition:	1
Urgency:	1

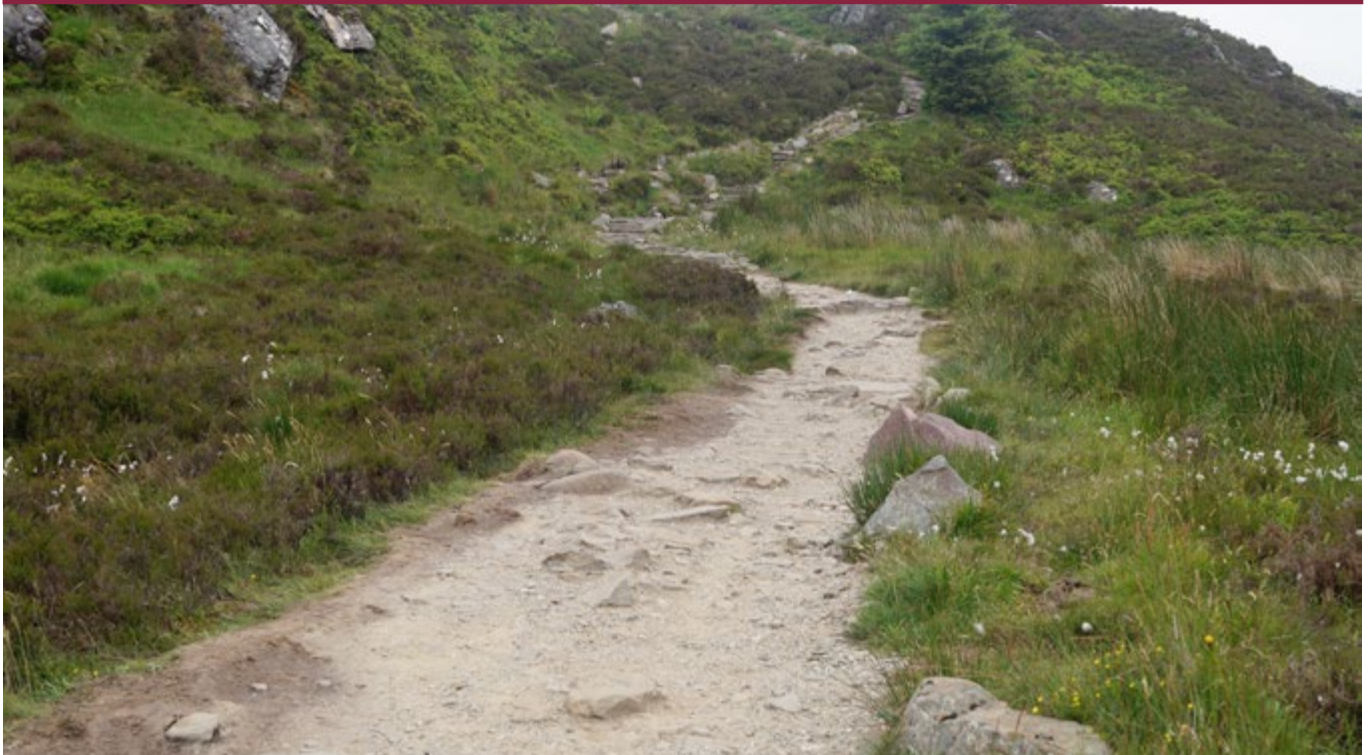
After works

Weather conditions: Sunny and dry	Date: 2nd July 2018
Path Name: Ben A'an	Surveyor: Rosie Winch
Start Grid Reference: NN 5095307041	End Grid Reference: NN 50733 08339
<p>General description of the Path: New stone pitching and aggregate path with good even surface. Section in very good condition</p>

Section:	5
Length:	373m
Grid Ref:	NN 5047107972
Surface Type:	Aggregate/ stone pitching
Features:	Boulders
Paths/Braids:	1/0
Bare Width:	1.2m
Tramp Width:	1.2m
Gully Depth:	0m
LG/XF:	18/21

Roughness:	5
Drainage:	5
Erosion:	5
Dynamism:	5
Condition:	5
Urgency:	5

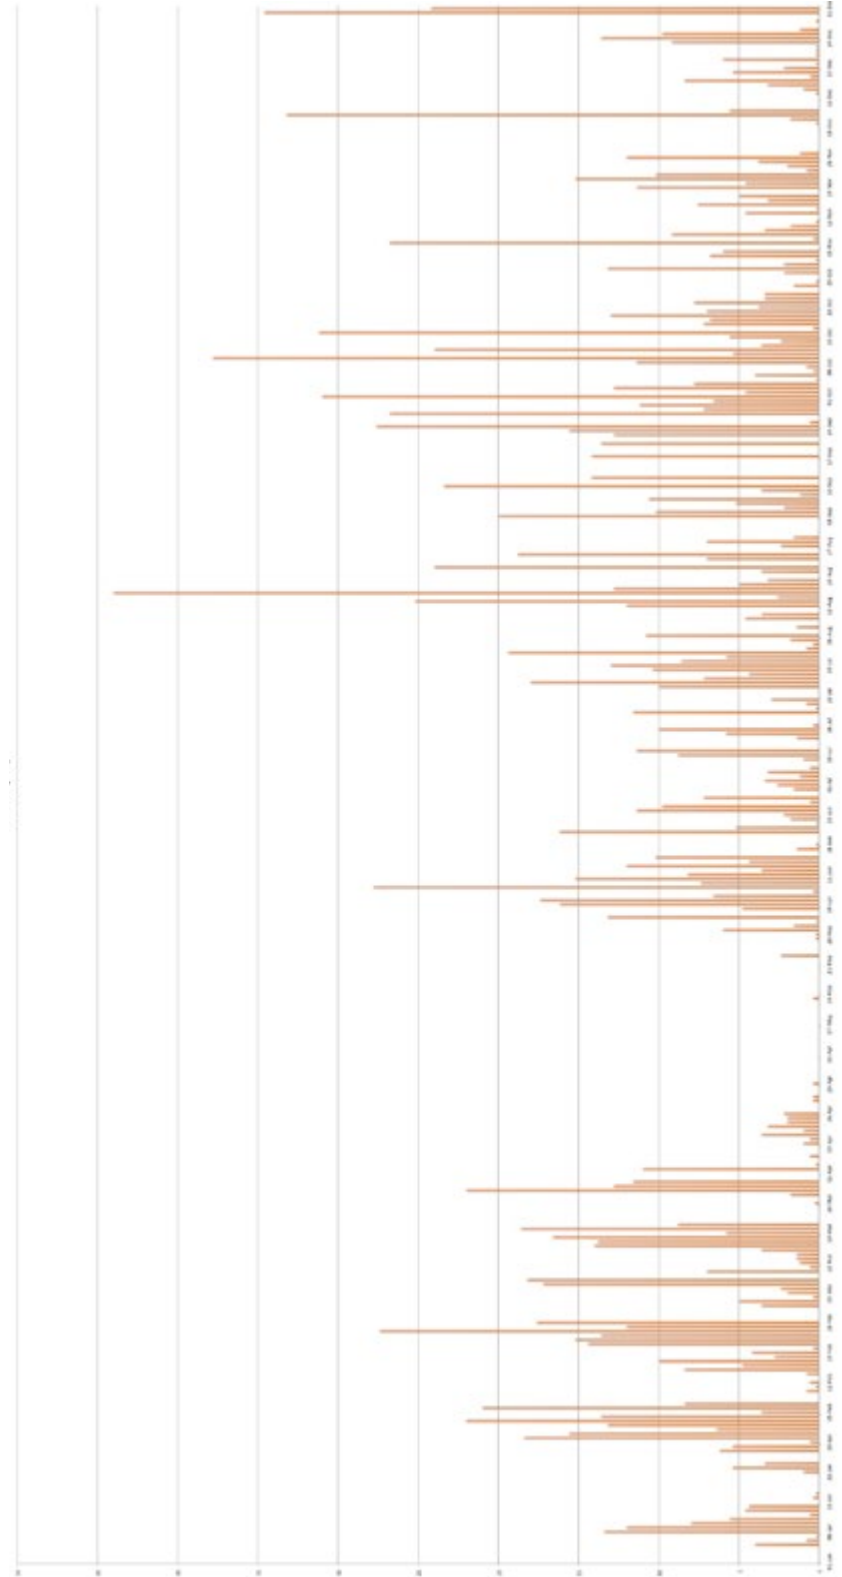
Ben A'an Rainfall Data in millimeters

Rainfall data for Loch Katrine near Aberfoyle in Loch Lomond & The Trossachs National Park

This data was provided by Scottish Environmental Protection Agency (SEPA) Evidence & Flooding Advice Helpdesk.
